The DNFM Technical News Letter

David N. French Metallurgists

Stress-Corrosion-Cracking

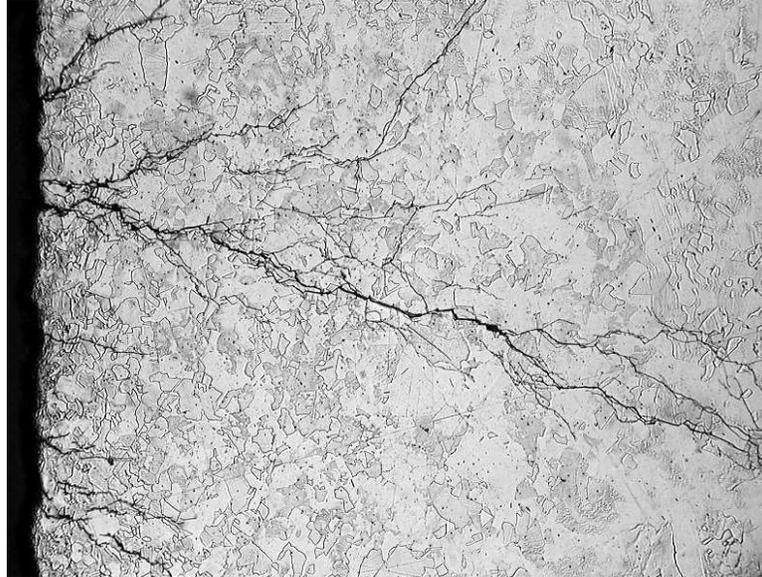
Figure 2. Severe branching of transgranular cracks in 304H stainless steel flange. 50x.

Stress-corrosion cracking can be either intergranular (along the grain boundaries), **Figure 1**, or transgranular (across the grains), **Figure 2**, or both, depending on the conditions. If a crack is induced by the brittle film in the ductile material then the crack will be arrested by ductile blunting. The film reinitiates by the corrosive species and propagates by the residual or applied stresses and this process repeats, resulting in transgranular cracking. Austenitic stainless steels exhibit either transgranular or intergranular cracking. The presence of sensitized austenitic grains may lead to intergranular cracking. Sensitized grain boundaries are less corrosion-resistant due to the depletion of chromium adjacent to the sensitized grains. Whether these SCC cracks are intergranular or transgranular with branching, as shown in **Figure 2**, they always exhibit brittle, thick-edged failures without any significant plastic deformation or wastage. Austenitic stainless steels, as well as austenitic super alloys containing large amounts of Ni, are made resistant to hydrogen embrittlement by cathodic reactions, due to a lower diffusion coefficient and higher ductility. But austenitic stainless steels are very susceptible to chloride SCC at room temperature and are severely

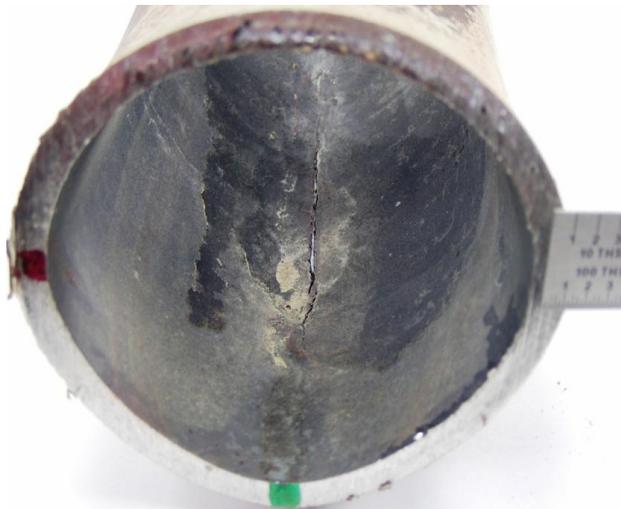
Figure 3. Stress-corrosion cracking at the bottom of a reheater tube bend.

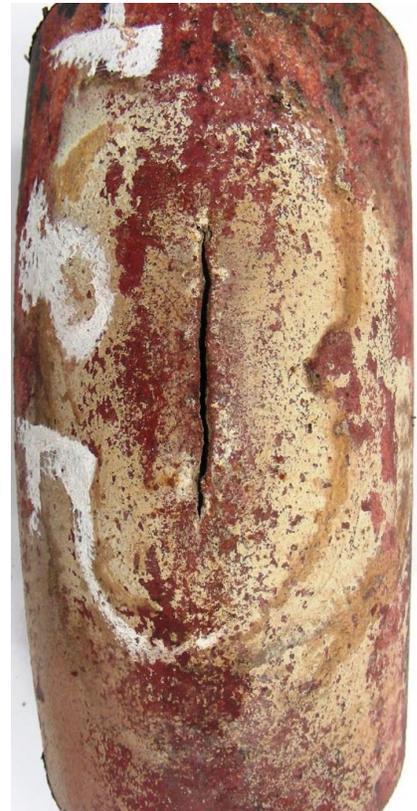
Figure 4. Caustic cracking in a reheater outlet tube, T22 Cr-Mo steel, intergranular cracking. 26x.

Caustic embrittlement was a significant factor in ferritic steels during the early 1900s due to caustic contamination associated with the riveted joints. Sodium hydroxide (NaOH) was once used for controlling pH of the boiler feedwater. The conditions for caustic embrittlement are concentrated hydroxide, tensile stress and elevated temperature. Nowadays, caustic SCC failures in the ferritic steels of superheaters/reheaters, **Figure 4**, may be the result of caustic introduction in the attemperator or desuperheater spray.

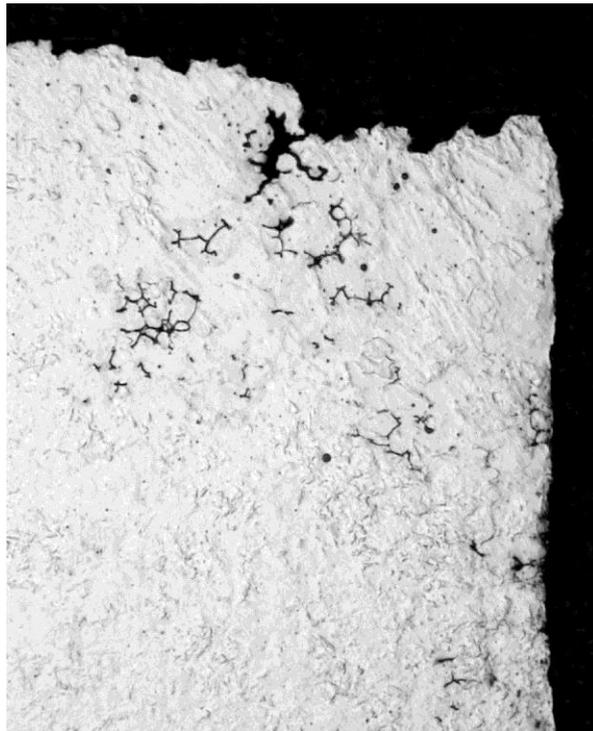
Figure 6. Hydrogen embrittlement damage in a chain link. 100x.

Hydrogen embrittlement is another form of SCC. When high-strength low-alloy steels with enough tensile stress are exposed to hydrogen, they may be subject to brittle failures, as shown in **Figures 5 and 6**. Hydrogen embrittlement is often the result of unintentional introduction of hydrogen into susceptible metals during forming or finishing processes, or during a corrosion reaction. Atomic hydrogen may be generated during a corrosion reaction and may diffuse into the steel, causing hydrogen embrittlement. Stress raisers due to geometric inequalities, manufacturing defects and service-related degradations increase the susceptibility to embrittlement. High-strength, low-alloy steels are very susceptible to this condition. Alternatively, austenitic stainless steels provide better resistance to hydrogen embrittlement. Steels with tensile strength of less than 140 ksi are not susceptible to hydrogen embrittlement. Hydrogen embrittlement is different from hydrogen damage, which is more often seen in boilers operating above 1500 psi. Hydrogen damage occurs without any tensile stress. In hydrogen damage, the atomic hydrogen is trapped underneath thick deposits and diffuses into the steel along the ferrite grain boundaries. Iron carbide in the steel reacts with diffused hydrogen to form a large molecule of methane. This large methane molecule cannot diffuse through the grain boundaries, so collects there and develops significant pressure, leading to grain boundary cracks and, eventually, a thick-edge, low-ductility failure. Depending on the extent of the damage, a complete decarburization may also occur in the microstructure. Hydrogen damage is more prevalent in acidic environments, but it can also occur in strongly basic environments.
